GRAMPAW PETTIBONE

Ferry Accident

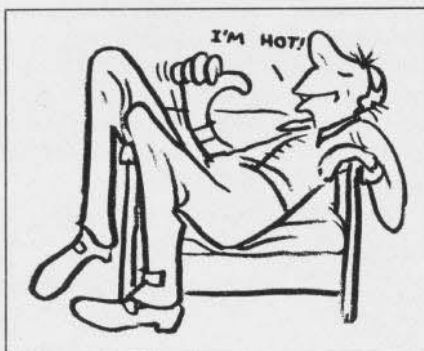
Mechanic Trouble

The pilot of an NE-1 taxied his plane to the line, cut the switch and left the aircraft. Just prior to his return, a mechanic pulled the propeller through to start the engine. The throttle was well advanced; there were no chocks under the wheels, and no one was in the aircraft. When the engine caught, the airplane at once

started to take off. The mechanic seized the starboard wing but was unable to maintain his grip and the aircraft became airborne. It failed to clear the boundary fence at the end of the field and was completely washed out in the following crash.

The Trouble Board said: All plane captains on this station have been warned of the absolute necessity for having a qualified person in the cockpit of every plane from the time the engine is started until the ignition has been turned off. Sufficient chocks have been distributed to all outlying fields where it is necessary to park planes for even a short period of time.

This aircraft was lost as the direct result of carelessness and disobedience of orders. Article 13-133 *Buair Manual* contains the regulations governing starting of aircraft engines. In this instance, the station concerned had also issued an order on the subject. Evidently a little more indoctrination and pressure is necessary in some cases.

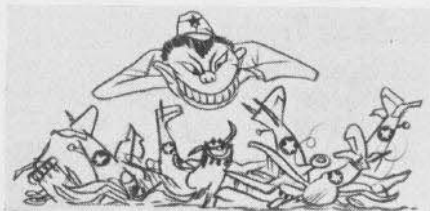
Case 1. During routine night flying the first student made his final landing, and while taxiing slowly to the end of

the runway was struck from the rear by a second student who had been signaled to land by the Night Flying Operations Officer. Before the damaged second plane could clear the area, another student was signaled to land. This third student landed slightly long, and while still in his landing run, collided with the second aircraft. In the opinion of the Trouble Board the Operations Officer was to blame for these two accidents in that he failed to determine a clear area before signaling additional airplanes to land.

Out of this mess of collisions, the Navy lost three primary trainers and had to replace major parts on four others. In the first two cases, the corrective measures are self-evident, but in the last case, which is a very common type of ground collision, there is a psychological factor involved which needs more attention—and that is this business of "assuming" things.
